INTERIM REPORT

LEAK OF RADIOACTIVE LIQUOR IN THE FEED CLARIFICATION CELL AT BNG THORP SELLAFIELD

REVIEW OF THE MANAGEMENT AND TECHNICAL ASPECTS OF THE FAILURE AND ITS IMPLICATIONS FOR THE FUTURE OF THORP

REPORT REF N° R3123-A2

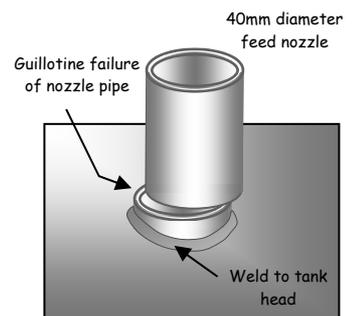
Accountancy Tank B – Nozzle Failure

Following the detection of the leak, an internal BNG Board of Inquiry reported in May 2005² states that remote cctv inspection of Cell 220 revealed a significant quantity of dissolver liquor in the base of the cell and that a feed pipe to one of the accountancy tanks (Tank B – nozzle N5) had failed by fatigue fracture at a location close to the head of the vessel.

The failure of the feed nozzle is in the form of a complete guillotine break of the 40mm diameter feed pipe just above the pipe to tank welded joint, with the disconnected pipe remaining slightly misaligned above the stub of the pipe. Because of this alignment, the gravity flow of the clarified feed liquor continued to run into the tank, with some of the flow splashing out and running down the tank side, spilling onto sections of the supporting steel frame.

- With the tank operating when suspended from the four tie rod hangers, the vibration of the tank induced by the internally mounted agitator (pulse jet) and during emptying by the reverse flow diverters produced both oscillatory and swaying motions of the tank that was, over time, sufficient to produce fatigue failure in the feed pipe.
- Although the tank system had been originally designed to be restrained within the seismic frame, for the pre-commissioning safety case the assumption was that the tanks would be uncoupled from the frame and, in accordance with this, the tank-frame restraint blocks were never fitted. Moreover, this modified

design never seems to have been reviewed and reassessed in terms of induced vibration and the associated cyclic stressing of the pipework connections.³

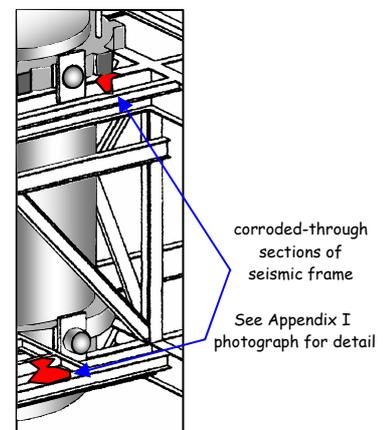
Associated Damage to Support Frame

Over the period of the leak, perhaps for about 9 months, the carbon steel frame sustained significant corrosion, with the spilling nitric acid etching into and completely eroding through the higher and lower south sections of the frame, including the 600mm wide web of the main I-beam at the lower level.

The damage to the steel frame appears to be extensive⁷ and repairs, even if possible by remote means operating within the cell, would require opening up the cell access hole which is presently only 300mm diameter to receive new sections of the 600mm web I-beam.

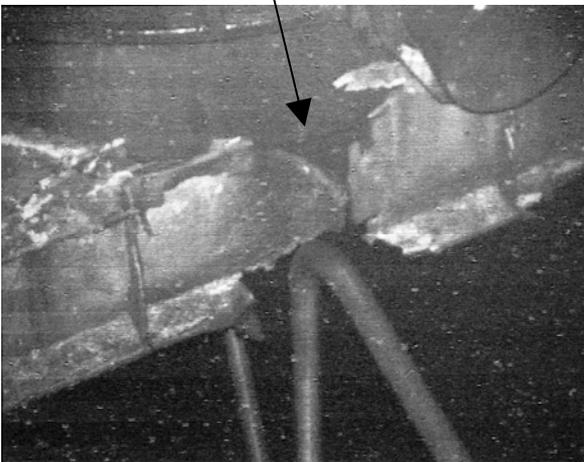
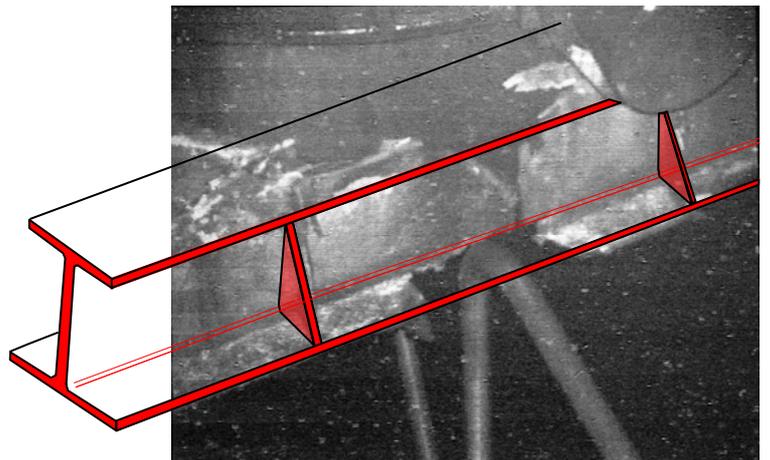
APPENDIX I – FRAME DAMAGE

- 7 The steel frame sections (I-beams) are only protected with paint and thus very susceptible to corrosion by the strong nitric acid content of the spilled clarified liquor. The extent of corrosion is given by some poor quality photographs in the NDA Review (11) which shows sections of both higher and lower level beams completely eroded through – Appendix 1.
