REVIEW

PROPOSAL TO RESTART UNIT 2

SAN ONOFRE NUCLEAR POWER PLANT

DEFECTS IN THE STEAM GENERATOR PRIMARY CIRCUIT TUBING

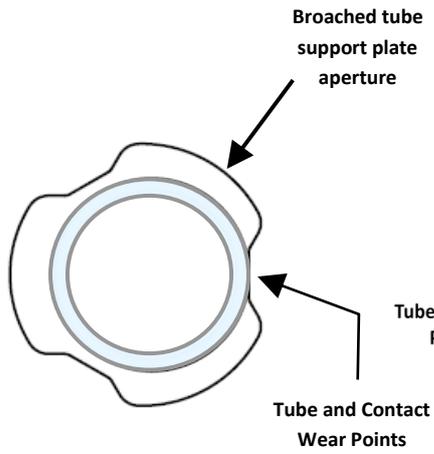
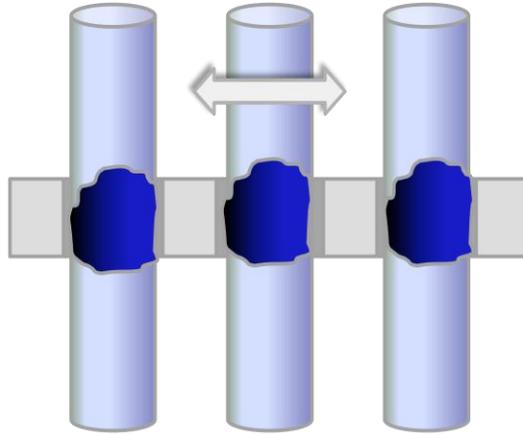
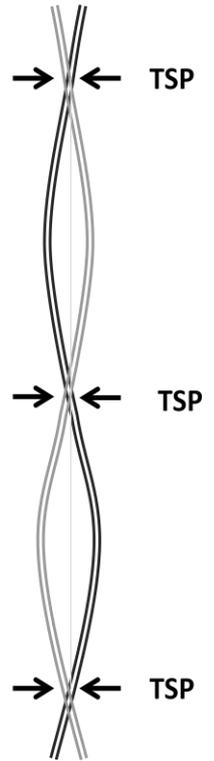
FIGURE 4A TUBE SUPPORT PLATE-TO-TUBE WEAR

MHI considered that FEI activity was suppressed in the region of the TSP localities and that this mode of tube wear arose from cross-flow induced random vibration; the AVB-to-tube wear was also related to

random vibration of the tubes which was exacerbated in some cases by twisting and distortion of the AVB itself; and the retainer rod-to-tube wear arose because of the flow induced vibration of the retainer rod abrading directly against the outer row of tubes (ie no tube motion), perhaps with this contact being brought about by the thermally-related distortion (flowering) of the tubes in the U-bend region of the bundle.

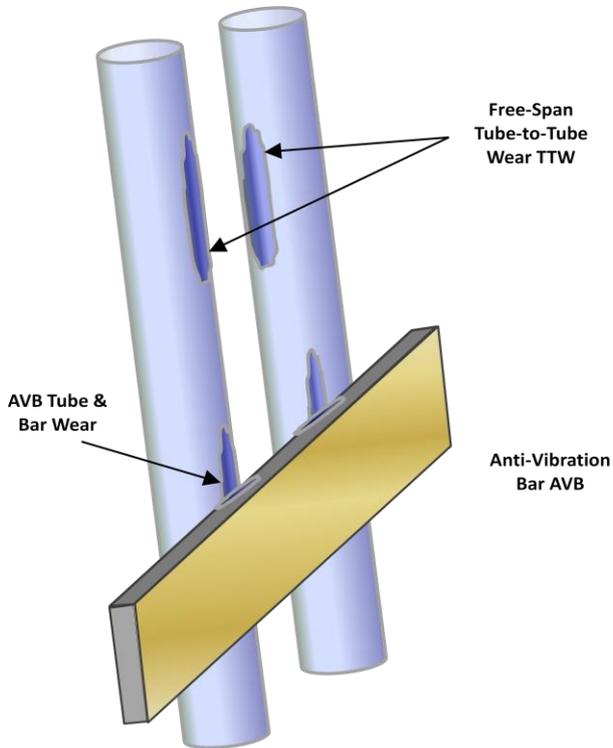
FIGURE 4B AVB WEAR & AVB-TO-TUBE WEAR

There remains acute disagreement between SCE's consultant AREVA and the RSG designer MHI as to the cause of the AVB wear and, particularly, how this will apply to Unit 2 if restarted {5.7.7-11}. AREVA claim that if the reactor power level is reduced to 70% then the cause of continuing AVB wear, *in-plane* FEI will cease, so AVB *in-plane* effectiveness will also cease to decline further, and TTW will be arrested. To the contrary, MHI reckons that the AVB wear is driven by random flow perturbations and not FEI, so the decline in AVB *in-plane* effectiveness will continue to advance even at the reduced 70% power level, thereby freeing-up longer free-span tube sections that are more susceptible to TTW.

Example of AVB Wear to L/H tube-to-bar

Example of AVB fretting To R/H tube with wear scar

- 4) *The MHI analysis considering TSP, AVB and RB wear modes for both Units 2 and 3 should be openly available in unredacted format; and, if appropriate,*
- 5) *the mechanisms and flow regimes inducing TSP, AVB and RB tube and component wear modes should be subject to benchmark simulation at the appropriate scale.*

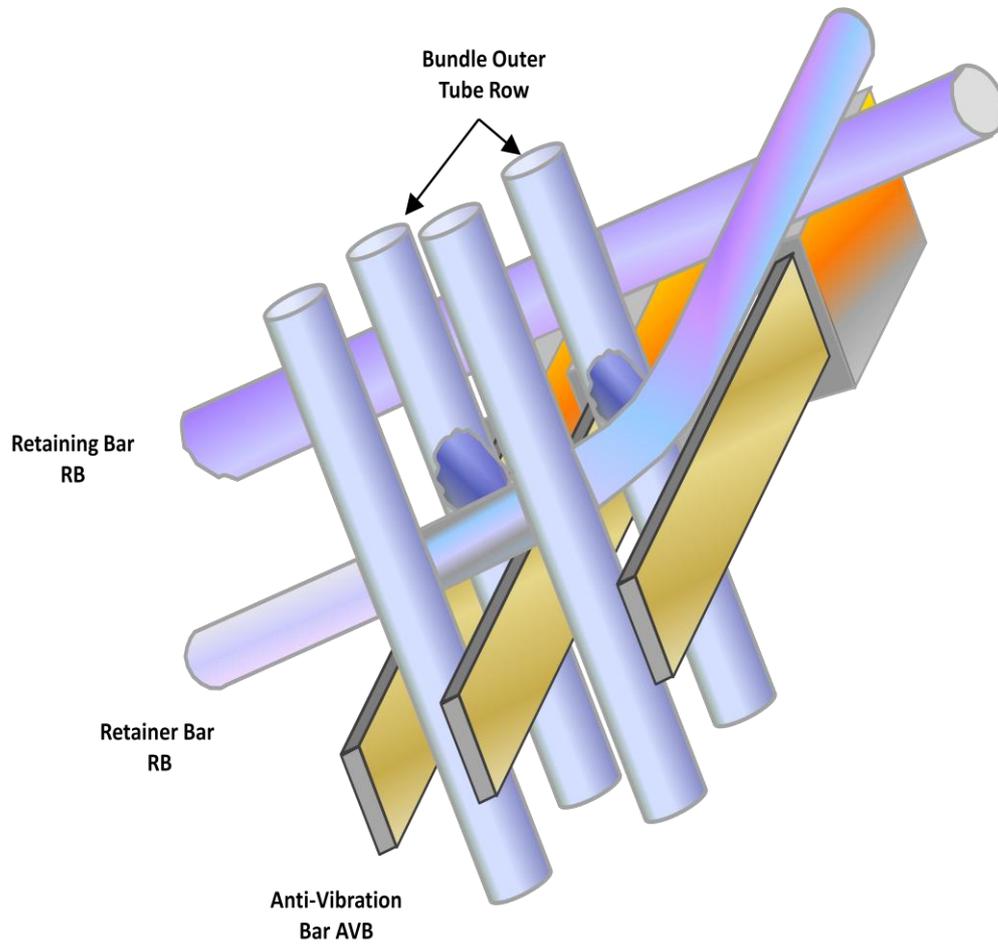
FIGURE 4C AVB ASSEMBLY RETAINER BAR-TO-TUBE WEAR

Quite distinct from FEI triggered tube motion, it is clear that both AVBs and the retainer bar (RB) assemblies were susceptible to flow-induced vibration, identified by MHI to arise between the low resonance frequency of the bracing retainer bars interacting with the turbulent secondary fluid flows leaving the tube bundle. The component motions excited by this fluid interaction resulted in quite harsh wear rates between the tubes and the retainer bars, at the AVB and, possibly, at the TSP localities.
