INTERIM REPORT

LEAK OF RADIOACTIVE LIQUOR IN THE FEED CLARIFICATION CELL AT BNG THORP SELLAFIELD

REVIEW OF THE MANAGEMENT AND TECHNICAL ASPECTS OF THE FAILURE AND ITS IMPLICATIONS FOR THE FUTURE OF THORP

REPORT REF N° R3123-A2

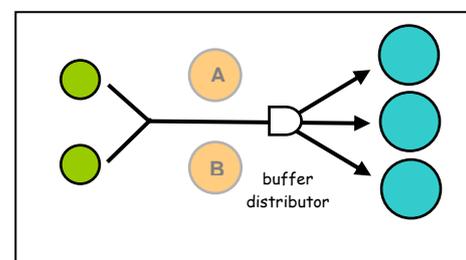
iii) By-Pass Both Accountancy Tanks A & B

In this option, both accountancy tanks (A and the damaged B) are by-passed with the centrifuged or clarified liquor being fed to any one of the three downstream buffer tanks, with the bypass piping either feeding by gravity or being pumped to the existing buffer tank distributor.

To bypass the remaining accountancy tank (iii) requires remote installation of new pipework directly from the centrifuge, either gravity fed or pumped to the buffer tanks, with the former option possibly resulting in a 20 to 30% reduction of batch throughput because of the height limitations for gravity feeding in the cell.¹⁸ Removal of the accountancy tank process stage requires modification of the head-end process overall to introduce a new weighing stage¹⁹ and plutonium valency conditioning.¹

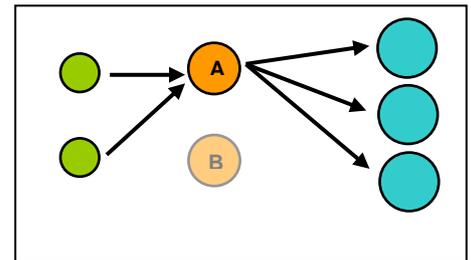
iv) Accountancy via Tank A Only

The damaged accountancy tank B is abandoned and the process continues operating only via the present Tank A, albeit with the amended procedure that the tank would only be lifted and suspended when weighing is required.

The use of just one accountancy tank would reduce THORP operational throughputs from in excess of 5 tonnes per day to 3 tonnes per day.

Even if the present continuous suspension mode for accountancy weighing is abandoned, further use of Tank A must be conditional on the fit-for-purpose condition of its nozzle and pipe connections. Before this option can proceed, these connections will have to be robotically inspected and subject to non-destructive examination. This is because Tank A has been in service and subject to the same conditions that failed the N5 connection to Tank B with at least the Tank A N5 connection being subject to the same number of sway and oscillatory fatigue cycles as its failed counterpart.²⁰

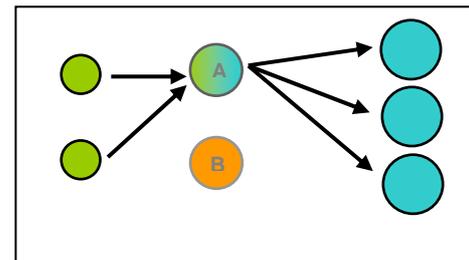
v) Tank A as Intermediate Stage Only

Tank A is utilised as a pump-through reservoir with accountancy being undertaken in the buffer tanks which enables the 5 tonne daily throughput to be maintained.

This is BNG's preferred option.

Tank A remains in use as a collecting and pump through reservoir, with accountancy being completed in the buffer tanks, thereby maintaining the 5 tonne daily throughput for THORP.

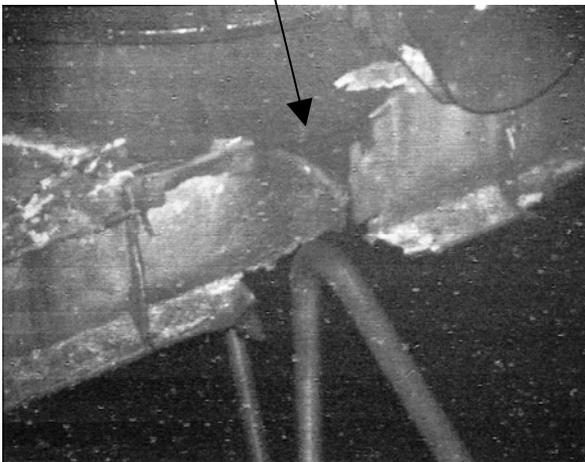
APPENDIX I – FRAME DAMAGE

- 7 The steel frame sections (I-beams) are only protected with paint and thus very susceptible to corrosion by the strong nitric acid content of the spilled clarified liquor. The extent of corrosion is given by some poor quality photographs in the NDA Review (11) which shows sections of both higher and lower level beams completely eroded through – Appendix 1.
