Forensic Assessments of the Nuclear Propulsion Plants of the Submarines HMS *Tireless* and RF Northern Fleet *Kursk*

John H Large

Large & Associates, Consulting Engineers

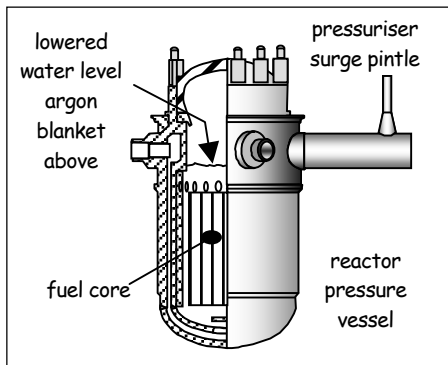
If the fault had been allowed to develop further then *Tireless* would have been at very real risk of catastrophic failure of the surge pipe junction which, being located inboard of the primary circuit isolation valves, could allow the reactor pressure vessel to rapidly depressurise and starve of coolant. Uncontrolled loss of coolant at this locality could have resulted in boiling of the coolant remaining in the reactor vessel, overheating of the nuclear fuel (even with the nuclear process shut down because of the continuing residual heat from fuel decay), the possibility of fuel melting and, in the extreme, a violent explosion leading to a radioactive release within a few minutes.^{2,3}

5 RPV and Surge Pipe Pintle

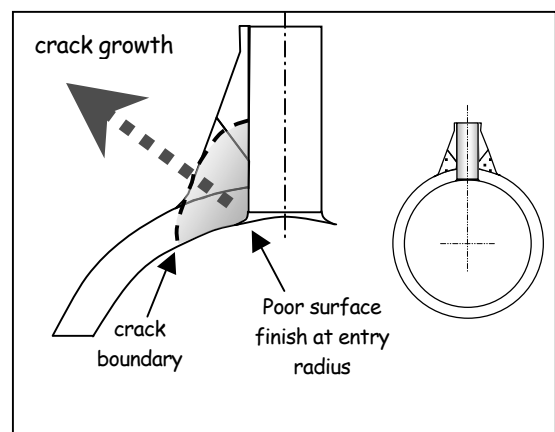
In fact, throughout this cool down and preparatory period the assumption had been that the fault was a single crack originating and confined within the pintle weld, that had grown from a flaw overlooked in the original build NDE radiographed certification of the weld and, importantly, that for the repair it would be sufficient to remove and replace just the pintle of the smaller diameter pressuriser surge pipe. However, once access for an in-pipe cctv viewing system had been established, the cracking was discovered to be very much more extensive, comprising two distinct centimetres long vertical fractures originating in the parent metal of the larger primary circuit pipework, and spreading upwards and outwards into the wall of the main pipe and pintle weld. The extent of the cracking required approximately one-quarter of the uppermost section of the primary circuit pipe at

6 Pressuriser Surge Line Pintle showing 1 of 2 thermally induced cracks

CNNRP concluded upon fuller inspection of the removed trepanned section, the cracking to have arisen from thermal fatigue resulting from slugs of cooler water cycling in and out of the mouth of the pressuriser surge pipe⁸ over many years of operation, although the final detailed results of the analysis of the removed pintle-main pipe section were never revealed to the Expert Panel advising the Government of Gibraltar.⁹ In the absence of proof otherwise, it may have been that the failure cause was more complex, resulting from a combination of thermal fatigue¹⁰ and thermal striping,^{11,12} the latter being relatively short-term in development. Another possible contributory factor to the cracking was the very poor (grooved) finish of what should have been a smooth, radius edge of the main pipe cut-out leading into the surge pipe, possibly containing latent crack initiators that could have developed over years of service.

the cracked junction to be trepanned out resulting in the need for a complete in situ reconstruction of the surge pipe junction.

Working up the new repair plan and the decision to replace the pintle design with a one-piece forged swept branch connector (a *Sweepolet*) further delayed progress on *Tireless* until November, thereafter there was stay-over whilst another *Trafalgar* class submarine was adopted as the lead boat to demonstrate the ease and validity of repair at the fully equipped Devonport Dockyard in the UK. *Tireless* was eventually fitted with the *Sweepolet*, passed NDE and the cold hydro test, being readied for nuclear power operations to leave the Port of Gibraltar on 8 May 2001, almost a year to the day that she ignominiously limped into Gibraltar under her emergency diesel power.

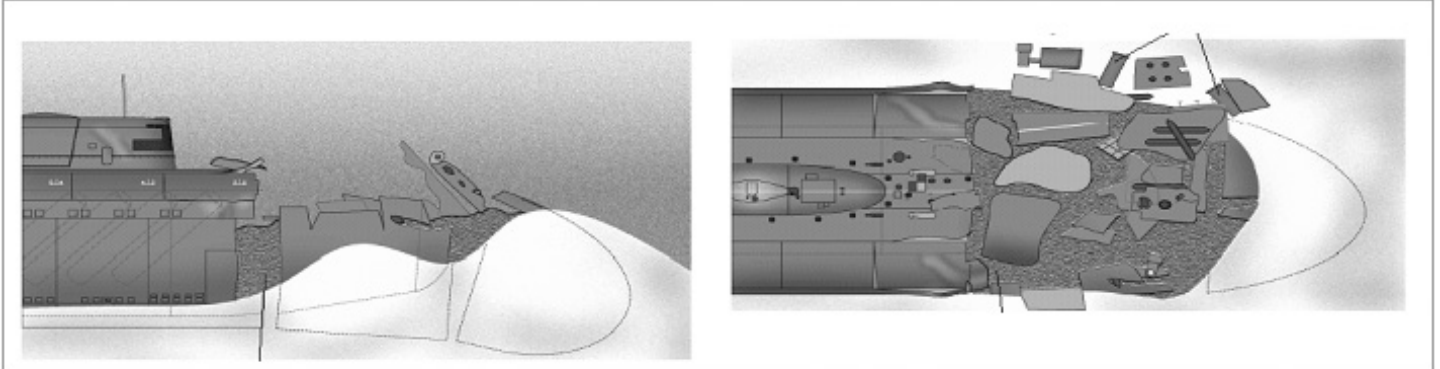
forward pressure hull (10 x 8m area) and outer casing and, at the same time, sending a reverberating hammer blow through the compartments towards the stern. Structural and flood bulkheads N° 2 and 3 were ripped through, with N° 4 buckling and subsequently collapsing under the hydrostatic flooding loads. N° 5, the forward reactor compartment bulkhead, and the remaining bulkheads through to the ninth compartment remained intact.¹⁵

7 Wreck of the *Kursk* – bow flood hull housing the forward seeking sonar has been displaced, the various cylinders are gas storage bottles, and the entire top section of the pressure hull of No 1 and No 2 compartments has been blown away

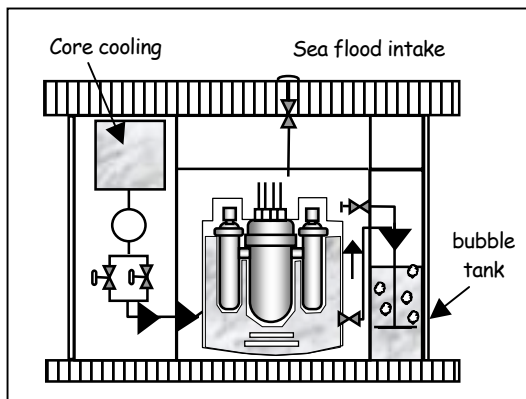
8 Integrated PWR plant (1 of 2) in Compartment No 6 showing schematic of emergency cooling systems

First, the capacity of the passive heat dissipation and emergency core cooling systems to protect the reactor cores was assessed.¹⁹ Observations for the range ship *Pyotr Velikiy* gave *Kursk* to be making a little over 6 knots on its torpedo run and, rigged in combat role, her reactors would have been powered to include for at least a 15% steam dump to the condensers, so all in all about 90MW_t for each reactor at the instant of boat electrical supplies being tripped out and, once and if this had been coped with, thereafter a residual heat of decay of about 10 to 15MW_t reducing (initially rapidly and then slowing over weeks) until equilibrium *thermal rollover* had been reached. The post-incident dissipation of the reactor core residual heat, with the reactors tripped and once that the turbines had spun down and the condensers lost vacuum, in the absence of any energised core cooling systems was considered to be the most challenging phase. This had been analysed by the Russian technicians earlier with the outcome suggesting that some parts of the fuel cores would have been unlikely to have survived the associated temperature excursions without damage. So with the condition of individual fuel element containments (cladding) doubtful but in the absence of any radioactivity emanating from within the reactor compartment, the assessment was that the pressure hull and bulkhead containment in the vicinity of the reactor compartment remained sound, with at least one other containment level (either the shield tank and/or primary circuit) intact.
