Forensic Assessments of the Nuclear Propulsion Plants of the Submarines HMS *Tireless* and RF Northern Fleet *Kursk*

John H Large

Large & Associates, Consulting Engineers

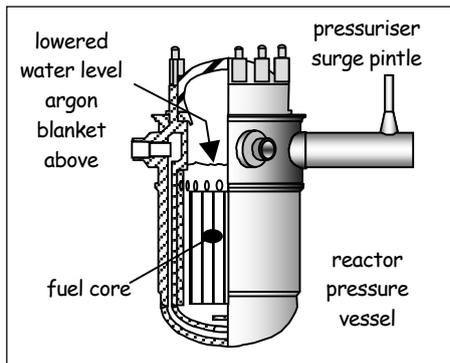
The fault in the reactor primary circuit of *Tireless* was first detected by the *leak-before-break* systems on board the submarine when she was submerged. The leak was located in the immediate locality of the welded pintle tee-junction of the pressuriser surge pipe and the main outlet pipe feeding from the reactor to one of the steam generators. The reactor was shut down following prescribed procedures, and the leakage rate estimated. It was then decided at high level within Ministry of Defence (MoD) and communicated back to the boat that the reactor could be restarted and the boat continue nuclear operations. However, after a few hours of running the leakage

If the fault had been allowed to develop further then *Tireless* would have been at very real risk of catastrophic failure of the surge pipe junction which, being located inboard of the primary circuit isolation valves, could allow the reactor pressure vessel to rapidly depressurise and starve of coolant. Uncontrolled loss of coolant at this locality could have resulted in boiling of the coolant remaining in the reactor vessel, overheating of the nuclear fuel (even with the nuclear process shut down because of the continuing residual heat from fuel decay), the possibility of fuel melting and, in the extreme, a violent explosion leading to a radioactive release within a few minutes.^{2,3}

5 RPV and Surge Pipe Pintle

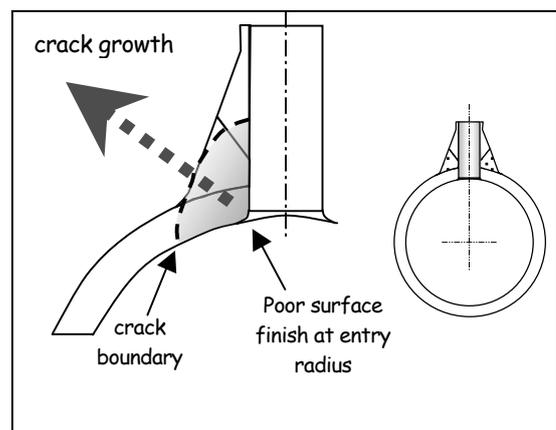
6 Pressuriser Surge Line Pintle showing 1 of 2 thermally induced cracks

CNNRP concluded upon fuller inspection of the removed trepanned section, the cracking to have arisen from thermal fatigue resulting from slugs of cooler water cycling in and out of the mouth of the pressuriser surge pipe⁸ over many years of operation, although the final detailed results of the analysis of the removed pintle-main pipe section were never revealed to the Expert Panel advising the Government of Gibraltar.⁹ In the absence of proof otherwise, it may have been that the failure cause was more complex, resulting from a combination of thermal fatigue¹⁰ and thermal striping,^{11,12} the latter being relatively short-term in development. Another possible contributory factor to the cracking was the very poor (grooved) finish of what should have been a smooth, radius edge of the main pipe cut-out leading into the surge pipe, possibly containing latent crack initiators that could have developed over years of service.

Working up the new repair plan and the decision to replace the pintle design with a one-piece forged swept branch connector (a *Sweepolet*) further delayed progress on *Tireless* until November, thereafter there was stay-over whilst another *Trafalgar* class submarine was adopted as the lead boat to demonstrate the ease and validity of repair at the fully equipped Devonport Dockyard in the UK. *Tireless* was eventually fitted with the *Sweepolet*, passed NDE and the cold hydro test, being readied for nuclear power operations to leave the Port of Gibraltar on 8 May 2001, almost a year to the day that she ignominiously limped into Gibraltar under her emergency diesel power.

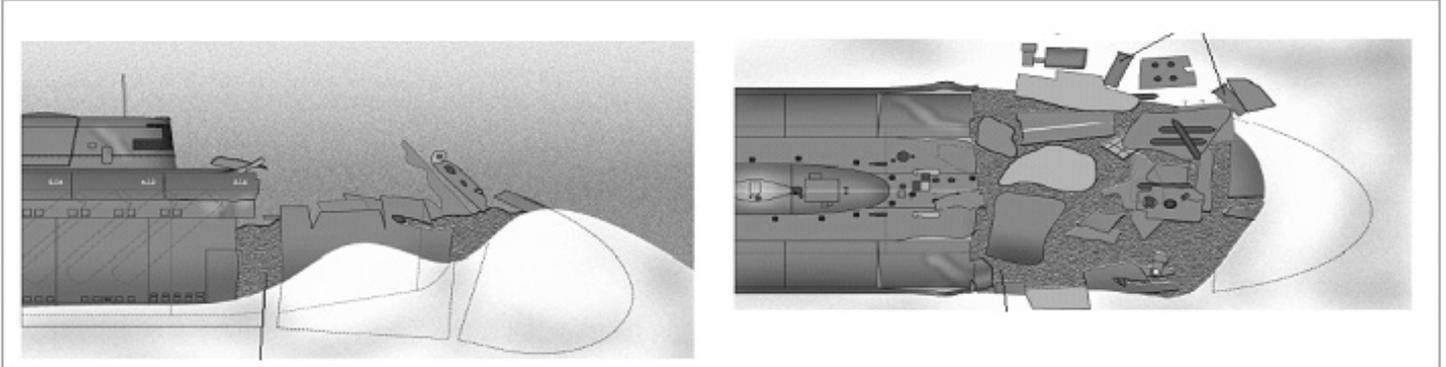
forward pressure hull (10 x 8m area) and outer casing and, at the same time, sending a reverberating hammer blow through the compartments towards the stern. Structural and flood bulkheads N° 2 and 3 were ripped through, with N° 4 buckling and subsequently collapsing under the hydrostatic flooding loads. N° 5, the forward reactor compartment bulkhead, and the remaining bulkheads through to the ninth compartment remained intact.¹⁵

7 Wreck of the *Kursk* – bow flood hull housing the forward seeking sonar has been displaced, the various cylinders are gas storage bottles, and the entire top section of the pressure hull of No 1 and No 2 compartments has been blown away

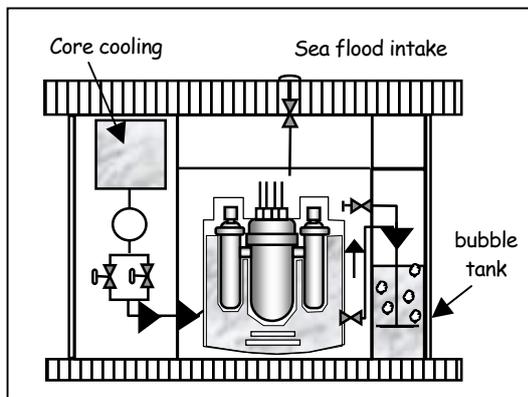
8 Integrated PWR plant (1 of 2) in Compartment No 6 showing schematic of emergency cooling systems

First, the capacity of the passive heat dissipation and emergency core cooling systems to protect the reactor cores was assessed.¹⁹ Observations for the range ship *Pyotr Velikiy* gave *Kursk* to be making a little over 6 knots on its torpedo run and, rigged in combat role, her reactors would have been powered to include for at least a 15% steam dump to the condensers, so all in all about 90MW_t for each reactor at the instant of boat electrical supplies being tripped out and, once and if this had been coped with, thereafter a residual heat of decay of about 10 to 15MW_t reducing (initially rapidly and then slowing over weeks) until equilibrium *thermal rollover* had been reached. The post-incident dissipation of the reactor core residual heat, with the reactors tripped and once that the turbines had spun down and the condensers lost vacuum, in the absence of any energised core cooling systems was considered to be the most challenging phase. This had been analysed by the Russian technicians earlier with the outcome suggesting that some parts of the fuel cores would have been unlikely to have survived the associated temperature excursions without damage. So with the condition of individual fuel element containments (cladding) doubtful but in the absence of any radioactivity emanating from within the reactor compartment, the assessment was that the pressure hull and bulkhead containment in the vicinity of the reactor compartment remained sound, with at least one other containment level (either the shield tank and/or primary circuit) intact.
