**BRIEF NOTE ON**  
**POSSIBILITY OF PRE-TSUNAMI SEISMIC DAMAGE AT**  
**FUKUSHIMA DAIICHI**

**CLIENT: GREENPEACE GERMANY**

**REPORT REF R3202-A1.DOCX**

**LARGE & ASSOCIATES**  
**CONSULTING ENGINEERS**  
**LONDON**

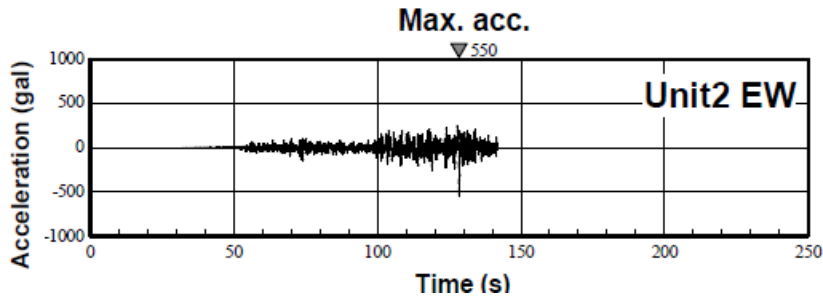
## UNIT 2 ACCELEROMETER RECORD OF THE 11 MARCH 2011 EARTHQUAKE - TEPCO

Of interest in the above tabulation are comparisons between the actual horizontal accelerations (NS and EW - 1<sup>st</sup> group in **RED**) recorded on 11 March 2011 to, first, the revised seismic qualification of 2008 (Ss mid columns) and, second, the original seismic design basis (right-hand columns). On 11 March, NPP Units 2, 3 and 5 were each subject to maximum accelerations that exceeded the 2008 seismic qualification (Ss) by about 20%,<sup>3</sup> although the exceedance is much greater (up to x2.2) the original design basis for horizontal ground motion.

So, obviously, the 11 March earthquake local effects at Fukushima Daiichi were greater than the 2008 seismic assessment of the Fukushima Daiichi site, meaning that the TEPCO 2008 requalification grossly underestimated to the potential seismic forces nominated for the Fukushima Daiichi site (the Ss value). In fact, it is not at all clear as to the extent and nature of physical work and plant modification that was actually undertaken by TEPCO for the 2008 seismic qualification upgrade – the IAEA fact finding mission of May-June 2011 clearly states that ‘*only some upgrading on piping supports was performed*’ and that ‘*no detailed information was provided [by TEPCO or NISA] regarding the physical upgrades [that were] effectively executed*’ ([IAEA](#) – p 70).
