RISKS AND HAZARDS IN RECOVERING THE NUCLEAR SUBMARINE *KURSK*

J H Large, Large & Associates, Consulting Engineers, London UK

SUMMARY

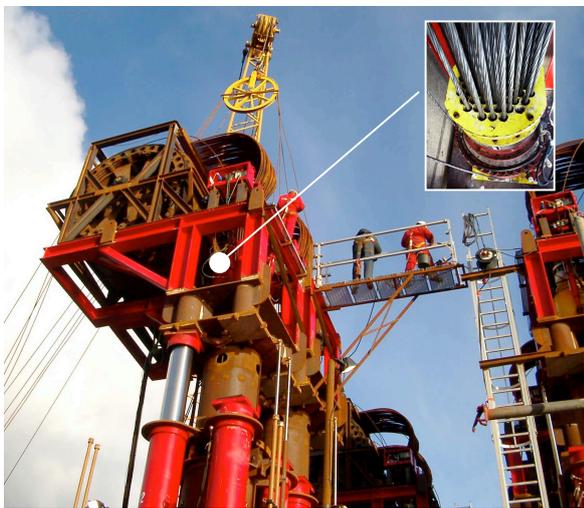
3 The strand jack (inset) mounted within the cable reel platform with the swell compensator rams underneath

Second, the installation of each of the grippers into pressure hull and raising the *Kursk* with Mammoet’s swell compensated strand jack system. The jacks would then hold the *Kursk* against the inverted cradle under the barge during transit to a floating dock at Rosljako Bay near Murmansk.

First, lifting operations could not proceed at sea state swell (peak to peak) heights greater than 2.5m because of the limit ram stroke of the Mammoet swell compensation

system acting on the strand jacks - this system maintained a uniform cable tension during the lift. The entire 110m lift was scheduled for at a minimum period of 10 hours so a fair weather window of at least this was necessary to ensure safety throughout the lift. If weather conditions deteriorated during the lift then the lift would have to be abandoned and the *Kursk* lowered back to the seabed.

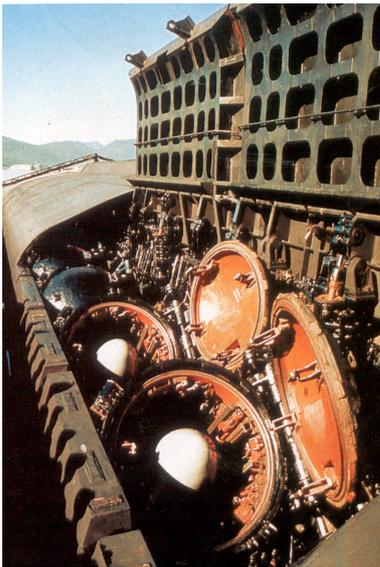
4 Starboard Missile Bank Forward - Silo Hatches Open

Missiles: At the time of loss, the *Kursk* was armed with 23 SS-N-19 GRANIT cruise missiles with conventional explosives. These missiles were located in forward slanting silo tubes, 12 either side of the submarine, the first being just behind N^o 1 compartment and within 3m of the cut line that was to isolate the bow wreckage, and the last two missiles being some 30m ahead of the reactor compartment.

Unlike a torpedo round explosion, which was considered to be credible and tolerable, full detonation of a single 760kg missile warhead could not be tolerated at any stage of the lift, conveyance from the wreck site and transfer to the floating dock because this would have imperilled all of those personnel manning the salvage vessels and had the potential to result in a release of radioactivity to the marine environment and hence to the M-S personnel. Thus, it was absolutely essential to determine the most unstable condition for the missile systems and the main fill and ejection charges and if any of the five AFS latches[15] had been enabled by the foundering explosions and the subsequent M-S recovery operations.

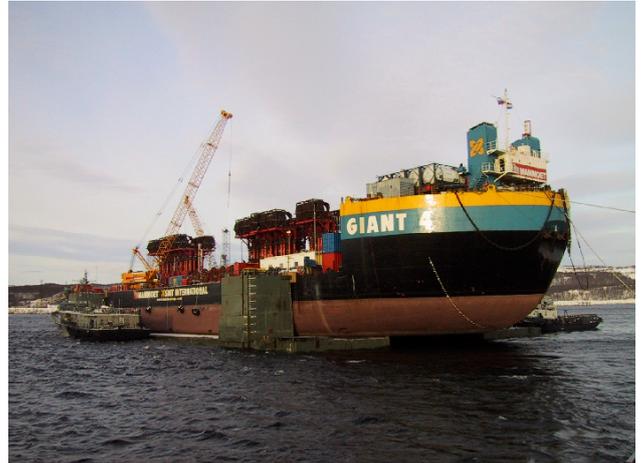
5 Giant 4 with the *Kursk* slung underneath awaits entry into the floating dock at Rosljakovo – two sinkable pontoons were deployed to raise Giant 4 for the necessary clearance into the floating dock

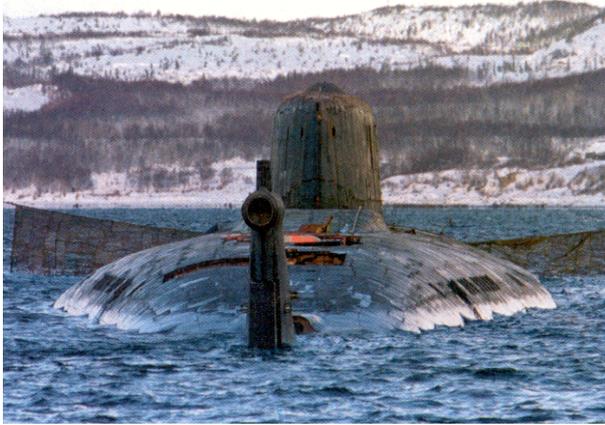
6 The Wreck of the *Kursk* Rising in the Well of the Floating Dock at Roslyako
