INTERIM REPORT

LEAK OF RADIOACTIVE LIQUOR IN THE FEED CLARIFICATION CELL AT BNG THORP SELLAFIELD

REVIEW OF THE MANAGEMENT AND TECHNICAL ASPECTS OF THE FAILURE AND ITS IMPLICATIONS FOR THE FUTURE OF THORP

REPORT REF N° R3123-A2

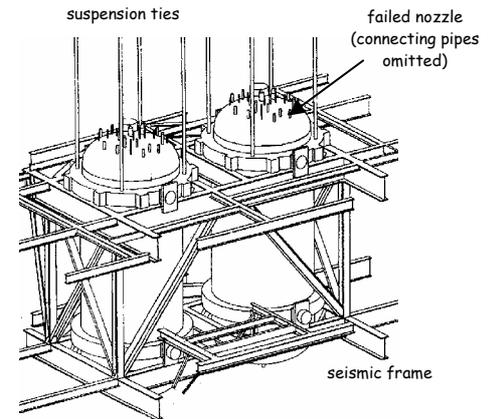
CELL 220 ACCOUNTANCY A & B

Both accountability tanks, each approximately 2.5m diameter by 4.5m length, are cradled in a seismic protection frame, although each tank is suspended free of this frame on four relatively slender stainless steel tie rods that pass through the ceiling of the cell to a weighing device. The normal operational state of the tanks is in the suspended mode with the tanks being lowered onto the frame for a short period whilst the weighing system is calibrated, usually twice yearly.
