REVIEW

PROPOSAL TO RESTART UNIT 2

SAN ONOFRE NUCLEAR POWER PLANT

DEFECTS IN THE STEAM GENERATOR PRIMARY CIRCUIT TUBING

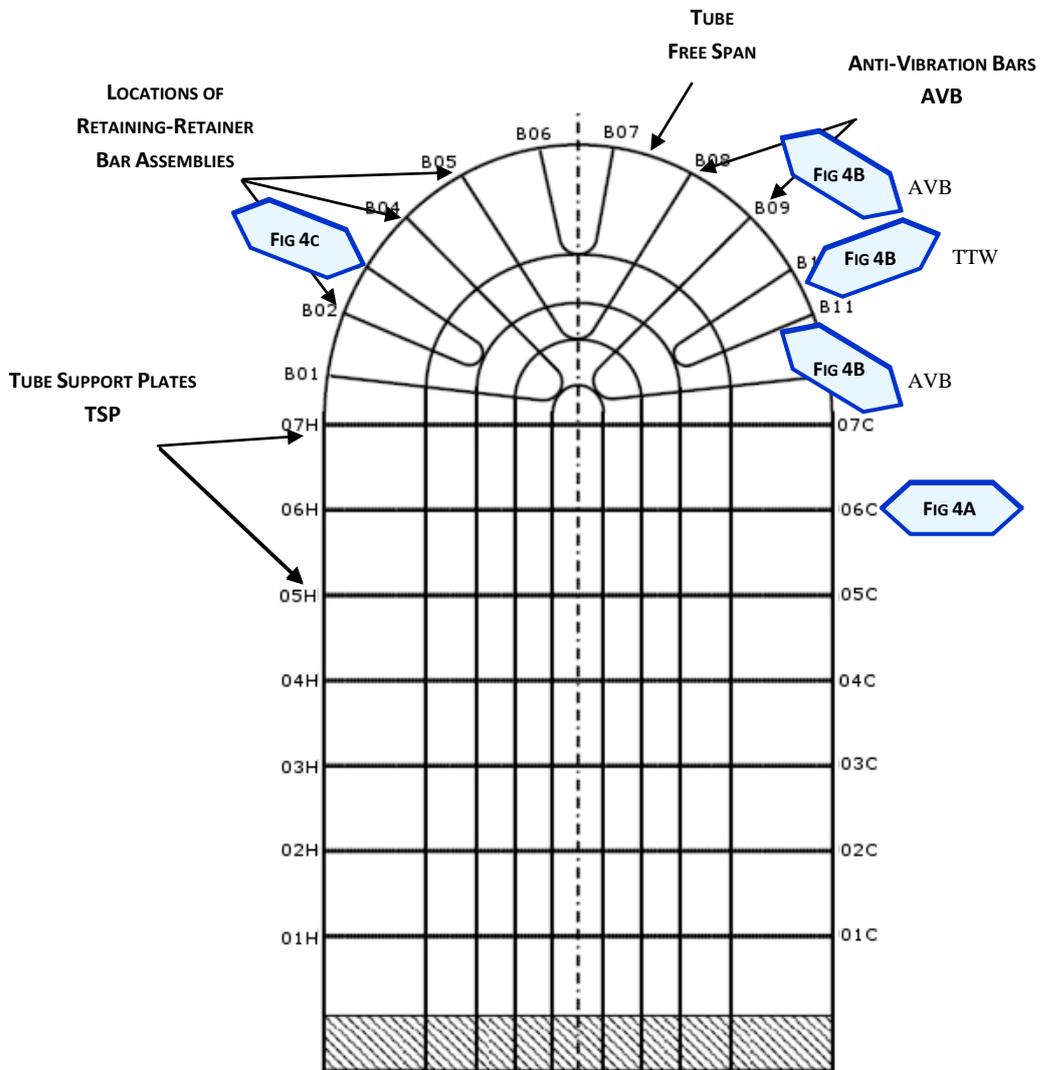
FIGURE 3 RSG COMPONENT LOCATIONS

The TSPs (FIGURE 4A) and AVBs (FIGURES 4B and 4C) provide points of restraint that arrest tube motion. The arrangement of the TSPs and AVBs is shown by (FIGURE 3). The TSPs acting at seven locations along each of the hot- and cold-leg sections of the tube bundle capture the individual tubes, via a broached piercing which minimizes lateral and radial tube motions whilst allowing some flow continuity at that particular tube location. The twelve AVBs act to restrain the tubes in the *out-of-plane* (OOP) direction by the tubes reacting against the AV bar which, itself, reacts against the next and successive *rows* of tubes. In this way the system of sandwiched AVBs obtains stiffness and restraint via the collective inertia of the tube bundle. Normally, because the dominant direction of motion experienced in SG tubing is in the *out-of-plane* direction (that is the least stiff axis of the individual U-bend section of a tube), the restraint acting against tube motion in the *in-plane* (IP – along the *columns* of tubes) direction is considered of secondary importance.
