**REVIEW OF
AGEING PROCESSES AND THEIR INFLUENCE ON SAFETY
AND PERFORMANCE OF
WYLFA NUCLEAR POWER STATION**

CLIENT: GREENPEACE UK

REPORT REF N^o R3049-A1

14 MARCH 2001

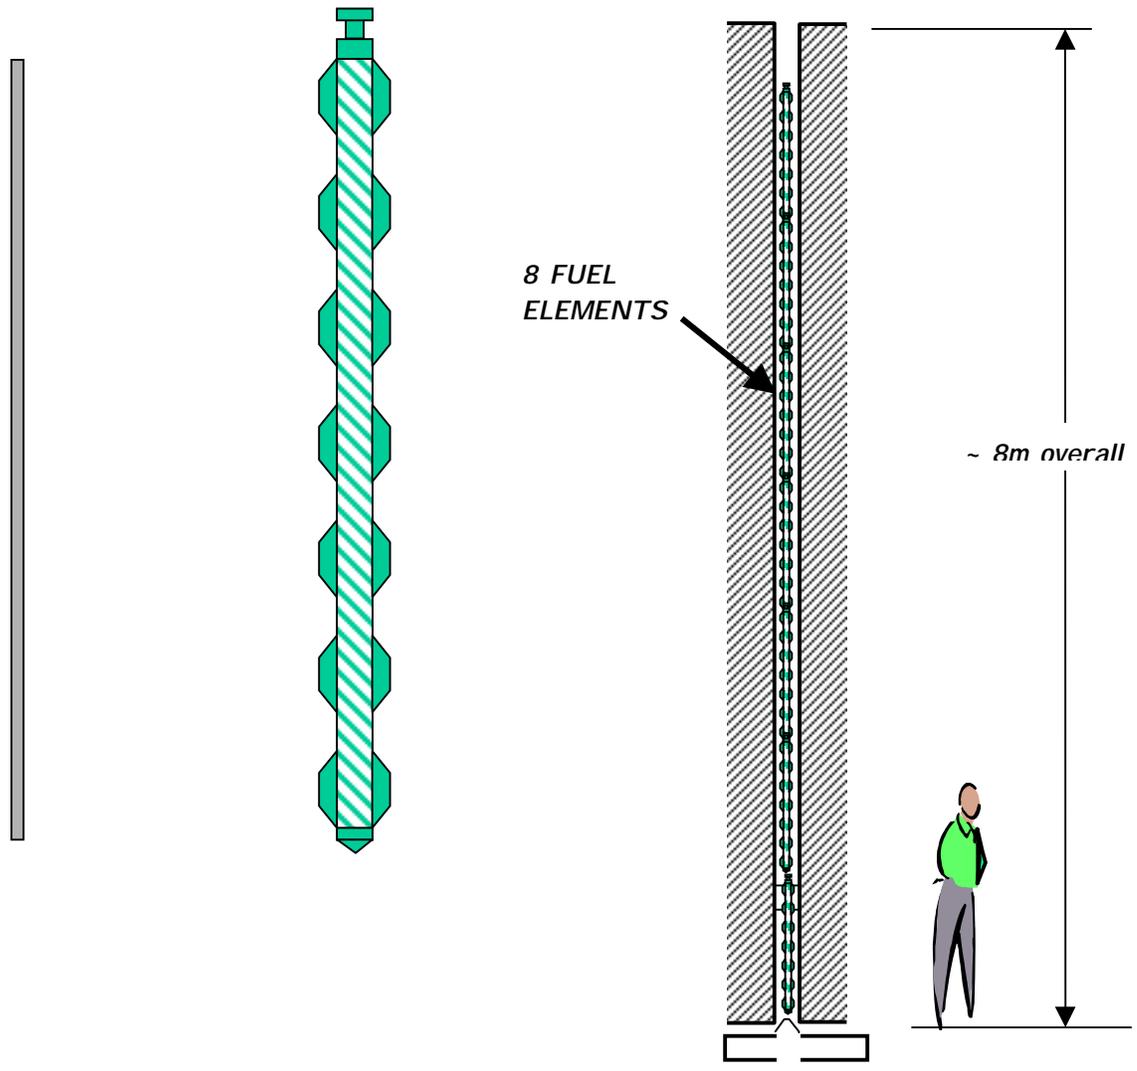
FIGURE 2 - MAGNOX FUEL SYSTEM

FUEL ROD

FUEL ELEMENT

FUEL CHANNEL

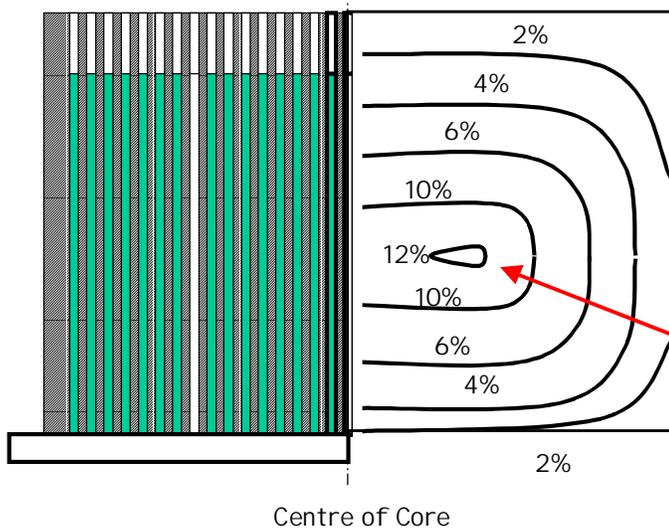
FIGURE 9 - RADIOLYTIC CORROSION OF THE GRAPHITE CORE

Graphite Weight Loss

Greatest weight loss in region of highest γ flux - so greatest deposit of dust in area of highest heat source of core - total weight loss could be as high as 27% by end of life (48% at channel walls)

Data:- Oldbury at 18 years

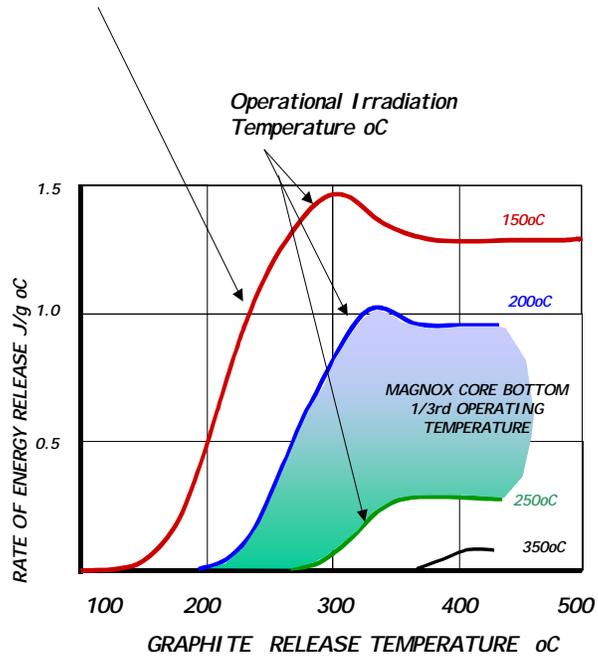
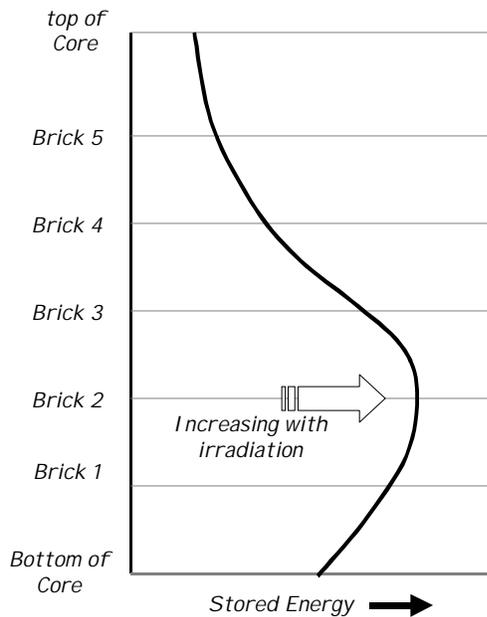
FIGURE 10 - WIGNER STORED ENERGY AVAILABILITY

TOTAL WIGNER N BOTTOM
1/3rd OF CORE

$$2.1E3 \times 3800 \times 1000 \times 1000 / 3 = 2.66E12J$$

DURATDN OF WIGNER RELEASE

$$740 / 40 = \sim 18 \text{ hours}$$
